Improved Concrete Cutting and Excavation Capabilities for Crater Repair

Phase 2

Report 2 of a series

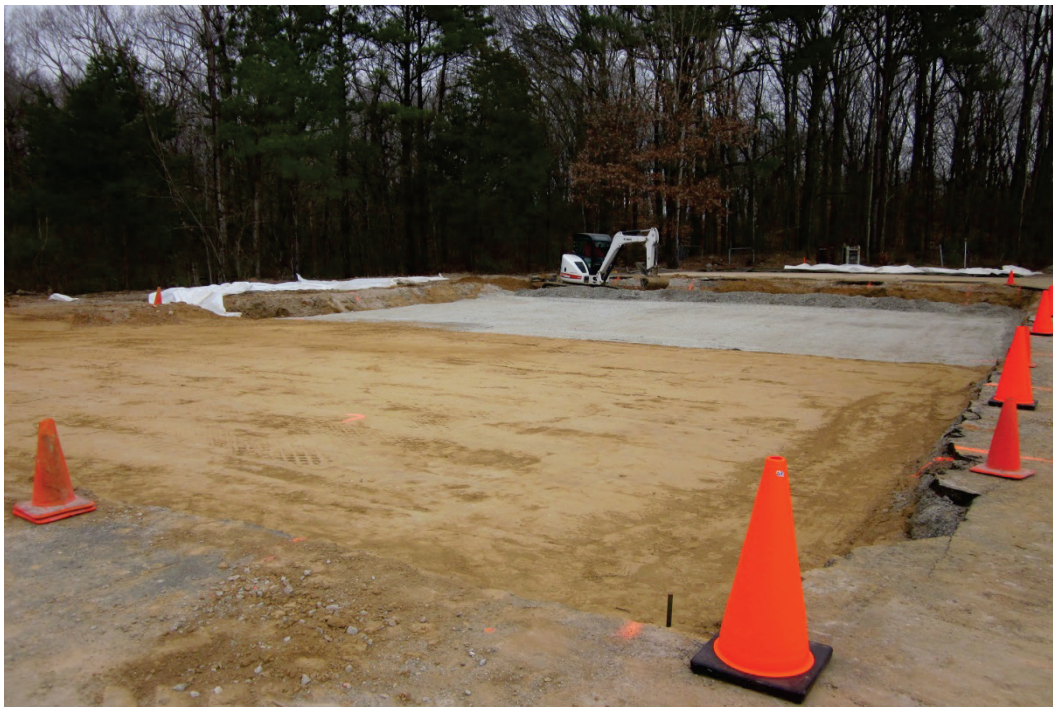
Figure 2. Test site construction preparation.

The existing subgrade was graded prior to construction with a 0.7 percent grade in the profile (east to west) and 0.3 percent grade south to north to allow for drainage (Figure 2). A drainage ditch was also constructed off the side of the center of the section (depicted in the far left of Figure 2). Silt was placed and compacted to a 12-in. depth over the western half (37.5 ft by 45 ft) of the test section as the base. For the eastern half (37.5 ft by 45 ft) of the test section, 6 in. of silt was used for the subbase, and 6 in. of crushed limestone was used as the base course. For the 24-in.-thick PCC section, 6 in. of limestone was used as the base course. Each layer was compacted to a target of 95 percent modified Proctor density or to the point that the in-place density did not increase with additional compactive effort. A Caterpillar CS433E vibratory smooth-drum roller and a Wacker WP 1550W plate compactor were used for compaction.

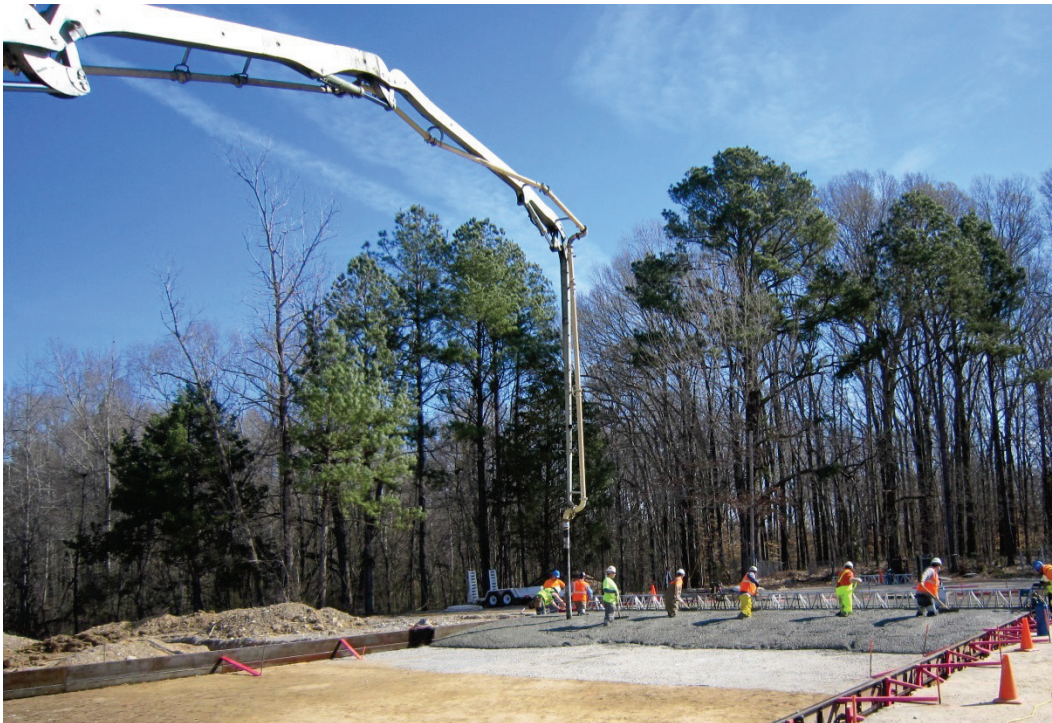
Figure 3. PCC placement using pump truck.

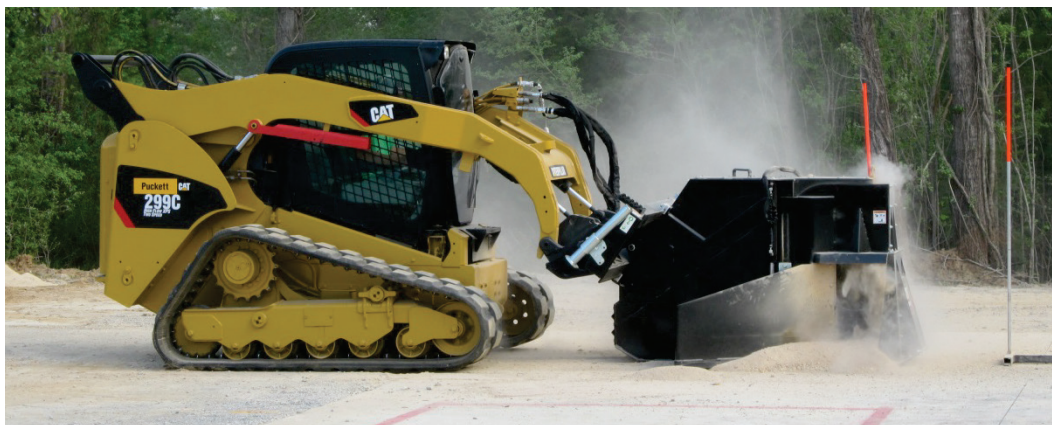
Figure 4. Caterpillar 299C CTL, operating the SW45 wheel saw attachment.

Caterpillar 279C compact track loaders (CTL), or skid steers, are high-flow, rubber-tracked machines with quick disconnect fittings that are used extensively in the current ADR TTPs. The quick disconnect allows attachments to be switched out rapidly without the use of tools. The Caterpillar 299C CTLs (Figure 4) are similar to the 279C CTLs except the 299C model has slightly more power and a higher operating capacity. The multi-purpose machines are employed for many of the ADR processes, including rapidly cutting around the upheaval area adjacent to craters in bomb-damaged pavement with wheel saw attachments, breaking pavement with the hammer attachment, removing debris with bucket attachments, screeding asphalt caps with the asphalt screed attachment, or cleaning up with the broom attachment. Specifications for the machines are listed in Table 3.

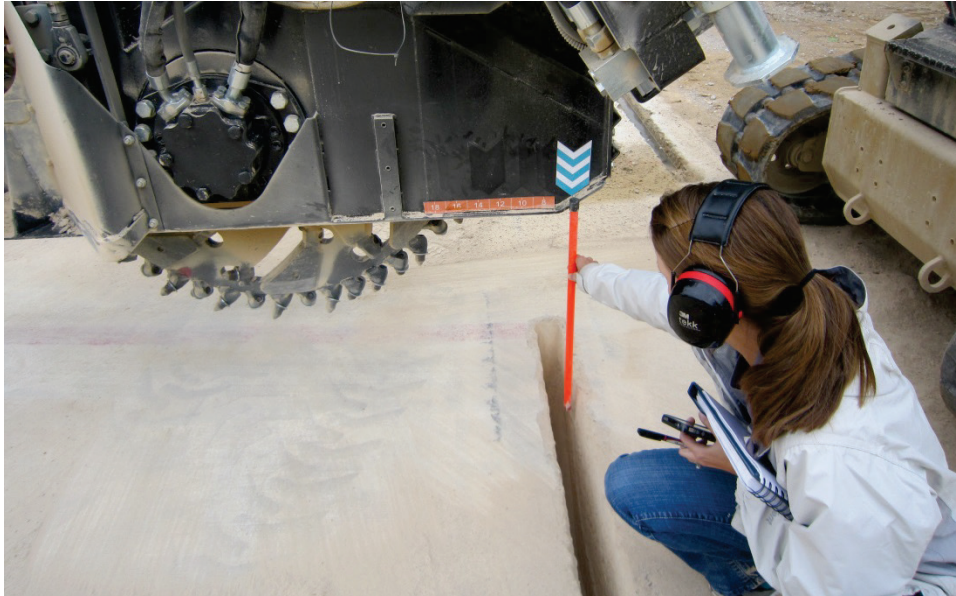
Figure 10. Using the rookie stick to line up to the edge of the crater.

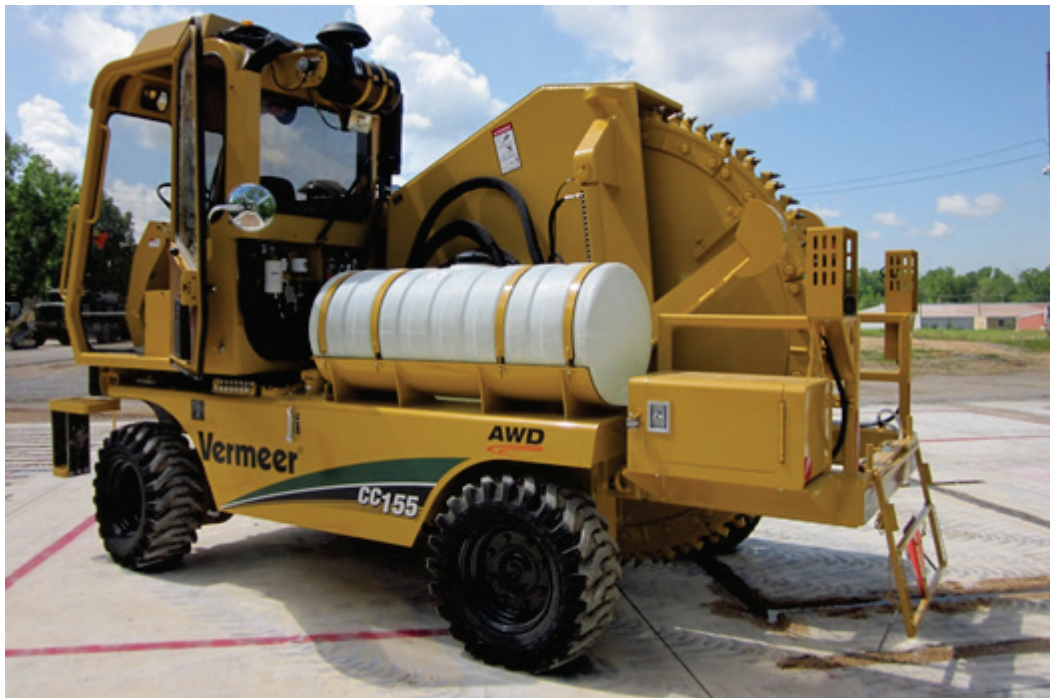
Figure 11. Vermeer CC155 concrete cutter with CC1531 wheel.

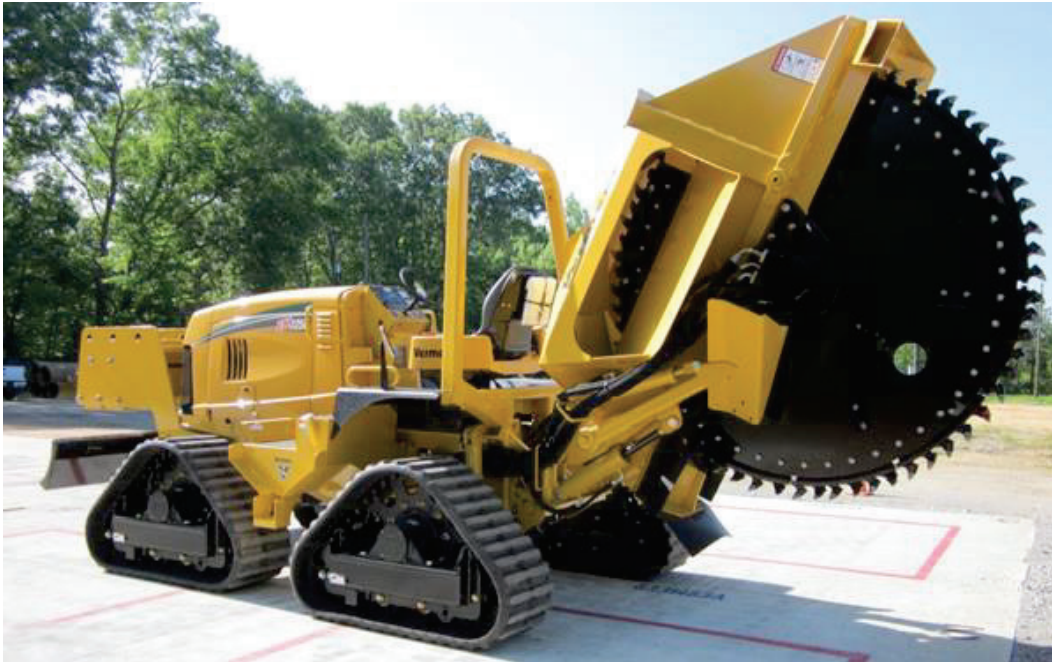
Figure 12. RTX1250 tractor with RW1236W rockwheel attachment.

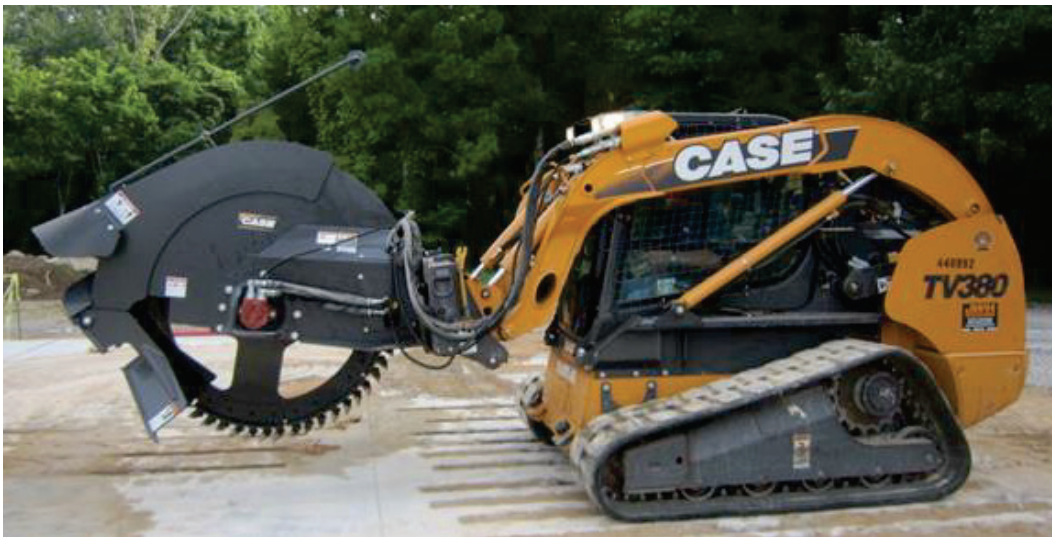
Figure 13. CASE TV380 with Bradco RS24 rock saw attachment.

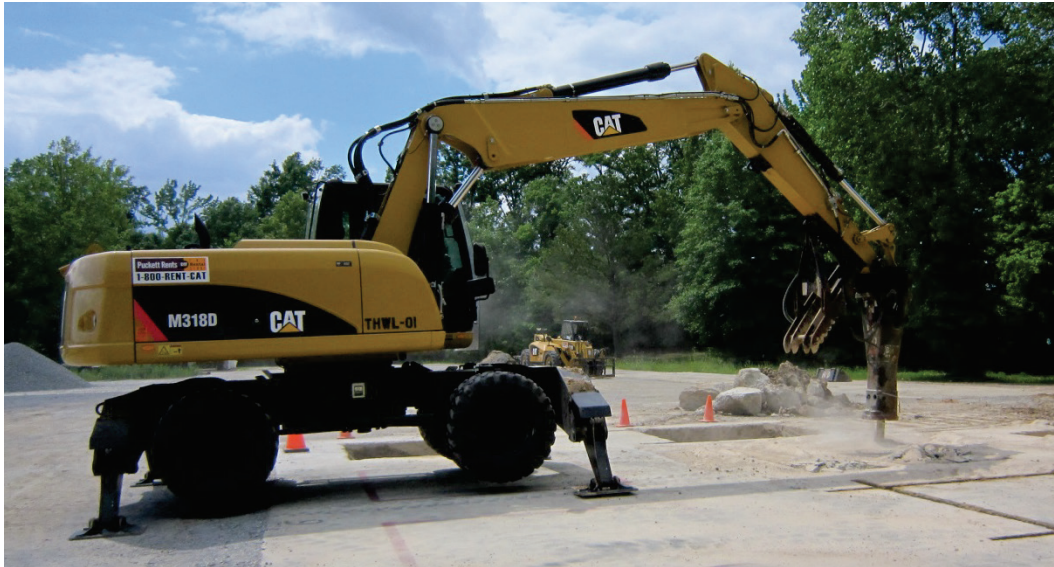
Figure 14. Caterpillar M318D excavator with H120E hammer.

A Caterpillar M318D wheeled excavator (Figure 14) or its equivalent is used in the ADR TTPs to break the PCC and excavate the broken PCC and underlying material. Wheeled excavators are preferred to tracked excavators for crater repair purposes because they minimize damage to the existing pavement around the repairs. The excavator is equipped with quick-disconnect fittings for the hammer and bucket work tool attachments. Table 10 presents the basic specifications of the Caterpillar M318D wheeled excavator.

The 18-in. and 24-in.-thick concrete was broken with amoil point Caterpillar H120E hammer (Figure 14). A 36-in.-wide bucket with a stationary thumb (Figure 15) was used for removing disturbed material. The teeth on the 36-in.-wide bucket were 8 in. long. Specifications for the Caterpillar H120E hammer are listed in Table 11.

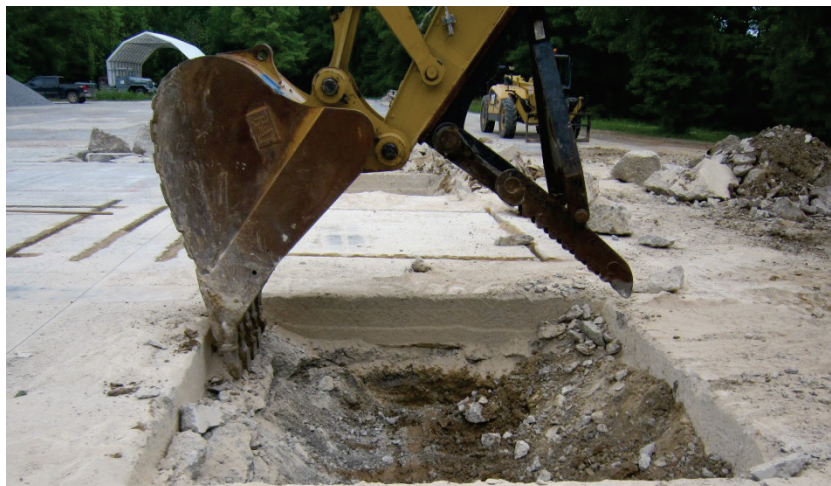
Figure 15. Excavator 36-in.-wide bucket.

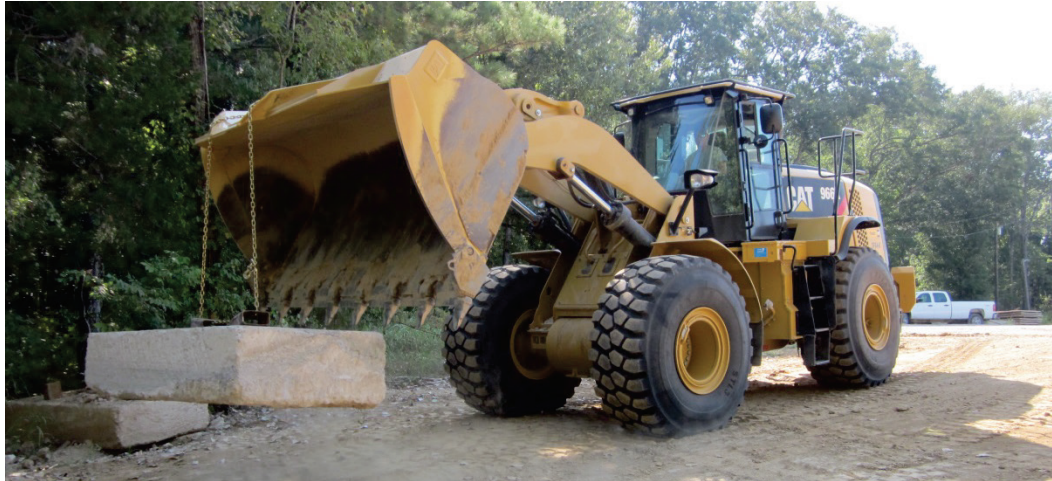
Figure 16. Caterpillar 966K front-end loader.

A front-end loader is a part of the ADR kit and is readily available. A Caterpillar 966K front-end loader with a 4-yd³ bucket (Figure 16) was employed for lifting sawed pavement sections by using anchoring systems and for general cleanup around the test site. The basic specifications for the Caterpillar 966K can be found in Table 12.

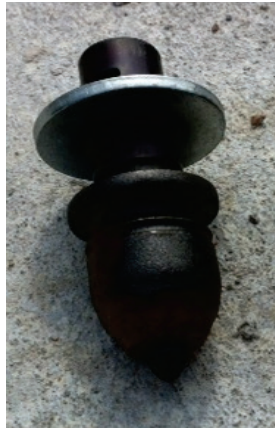
Figure 21. Wheel saw teeth, CAT model 227-7340.

The Caterpillar model 227-7340 concrete cutting tools (Figure 21) are the standard teeth sold with SW45 and SW360B wheel saw attachments. Previous testing (Bell et al. 2014) showed that these teeth produced

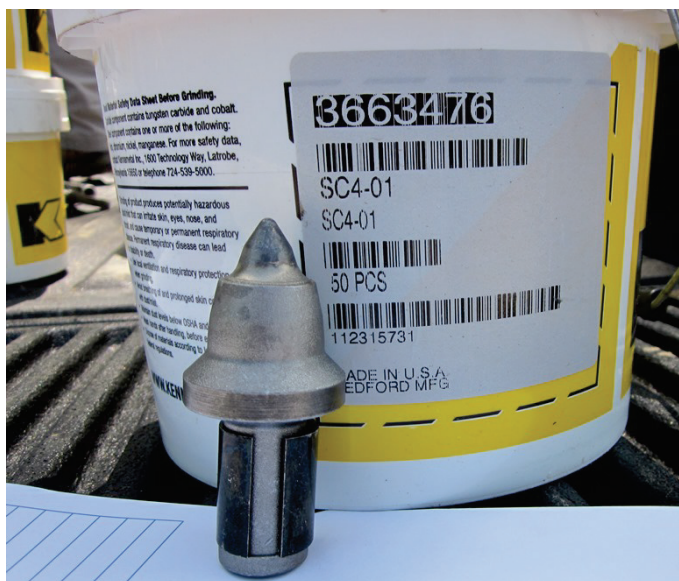
Figure 22. Wheel saw teeth, Kennametal model SM08.

*Measurement unit in parenthesis is mm; other is in.

The Kennametal model SM08 is a trenching tooth made of forged steel with a tungsten carbide insert with a 0.86-in.-diam shank. The 0.86-in.-diam shank fits in most Vermeer wheel saw attachments. The teeth are designed for use on soft, medium, hard, abrasive, or laminated rock. Figure 22 presents a diagram (Kennametal 2010) and picture of the teeth.

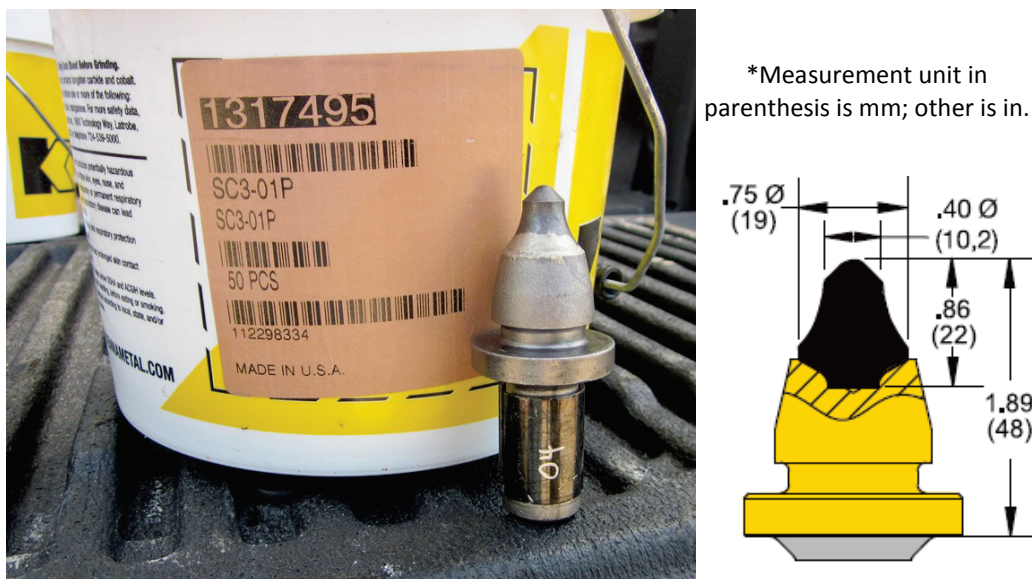
Figure 23. Wheel saw teeth, Kennametal model SM04.

The Kennametal model SM04 cutting tools are made of forged steel with a tungsten carbide tip and have a 0.86-in.-diam shank. The teeth fit most Vermeer saw equipment. The teeth are made for cutting through hard asphalt, concrete, or semi-rocky conditions (soft, medium, or abrasive rock). Figure 23 shows a diagram (Kennametal 2010) and picture of the SM04 teeth.

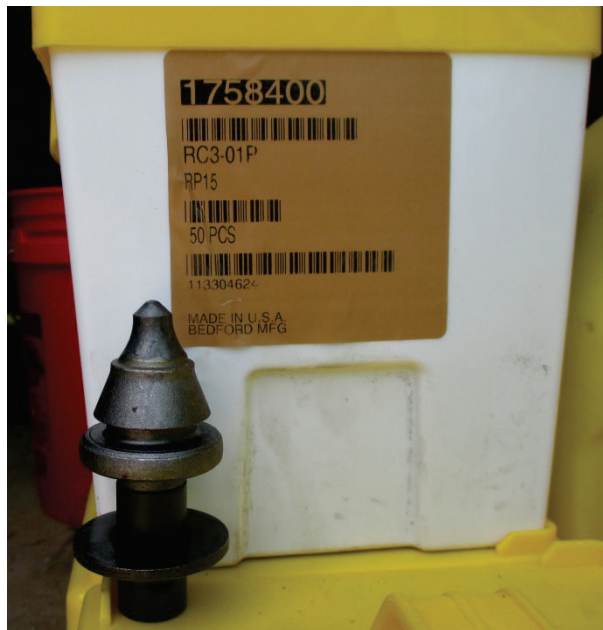
Figure 24. Wheel saw teeth, Kennametal model RP15.

*Measurement unit in parenthesis is mm; other is in.

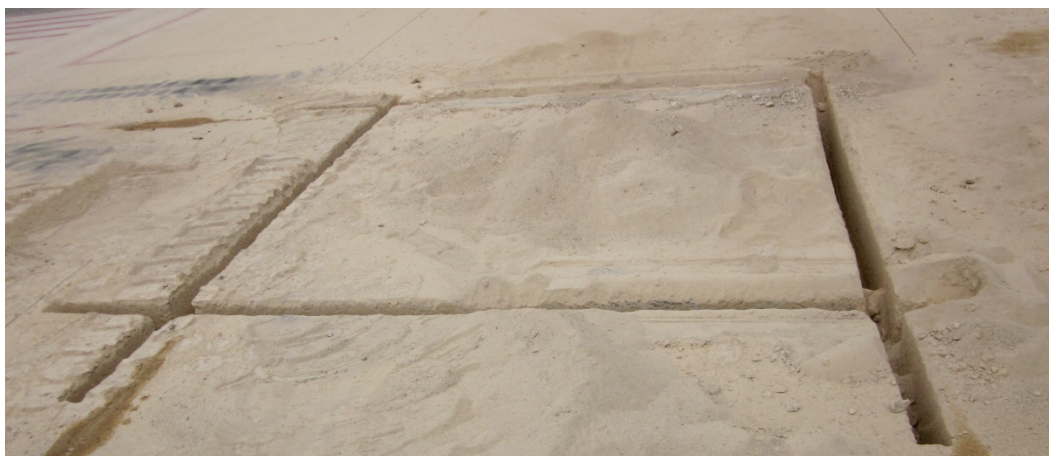
Figure 25. Long overcut lengths, as seen on Crater 8.

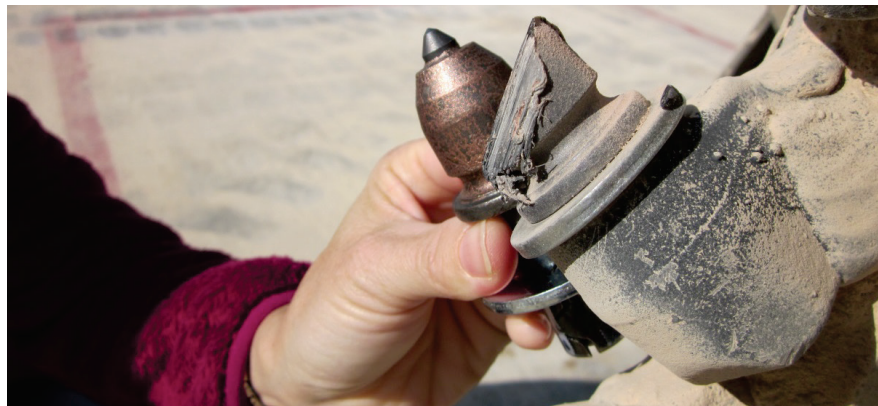
Figure 27. Worn concrete teeth after cutting, CAT model 227-7340.

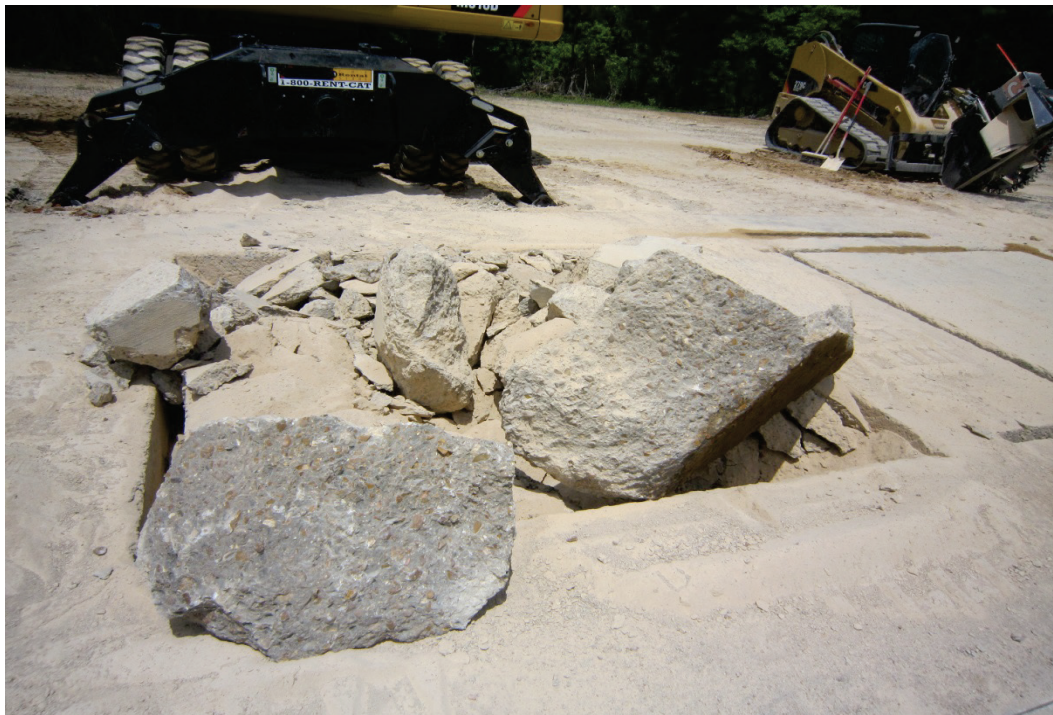
Figure 43. Crater 10, with no overcuts and less-than-full-depth cuts.

The PCC was cut to a depth of 15.5 in. for Craters 4 and 10. This was purposely done to see what effect the 2.5-in. less-than-full-depth cut had on the breaking and removal times. The breaking time required for Crater 4 was 8.25 min, which was the second longest break time. The less-than-full-depth cut and the little-to-no overcuts (less than 2 in.) caused an increase for the breaking time of Crater 4 because of the need for more breaks with the excavator hammer. The breaking of this crater also cracked the four corners of the parent slabs. Two of the corner breaks spread to the adjacent slabs and cracked to their existing cut lines. As a result, the excavator operator began breaking in the center of the sawed area for the remaining craters. The removal time was longer than most others due to the amount of small PCC debris.

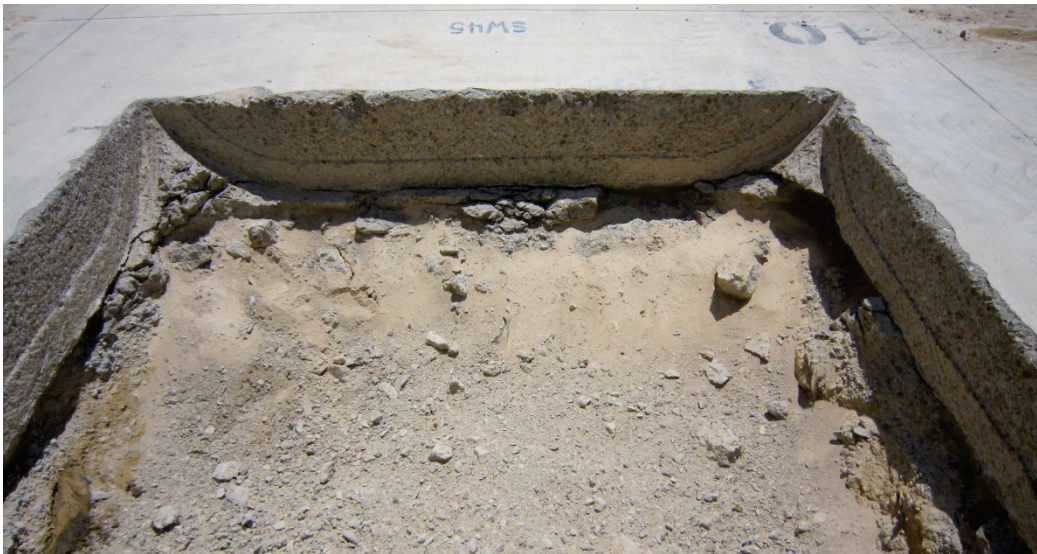
Figure 44. Crater 10, with attached PCC at the corners.

The 0-in.-long to 3-in.-long overcuts for Craters 4, 5, 10, and 11 left attached PCC remnants which began at the corners and broadened to the base of the repair. Figure 44 shows the attached PCC in the corners of a removed PCC section. This attached PCC also contributed to the longer breaking and removal times. It was difficult to get the 36-in.-wide bucket in the hole and remove the debris with PCC still attached in the corners.

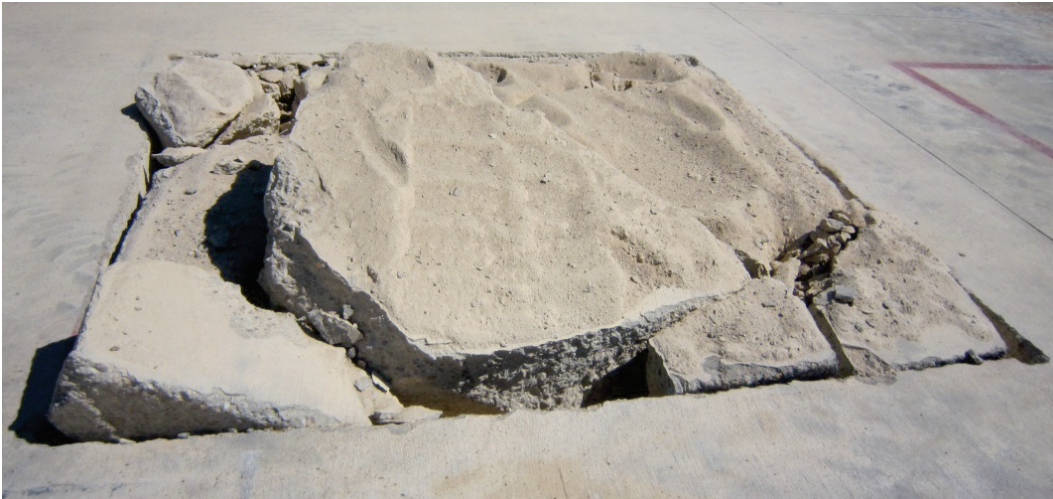
Figure 45. Crater 5, with short overcuts.

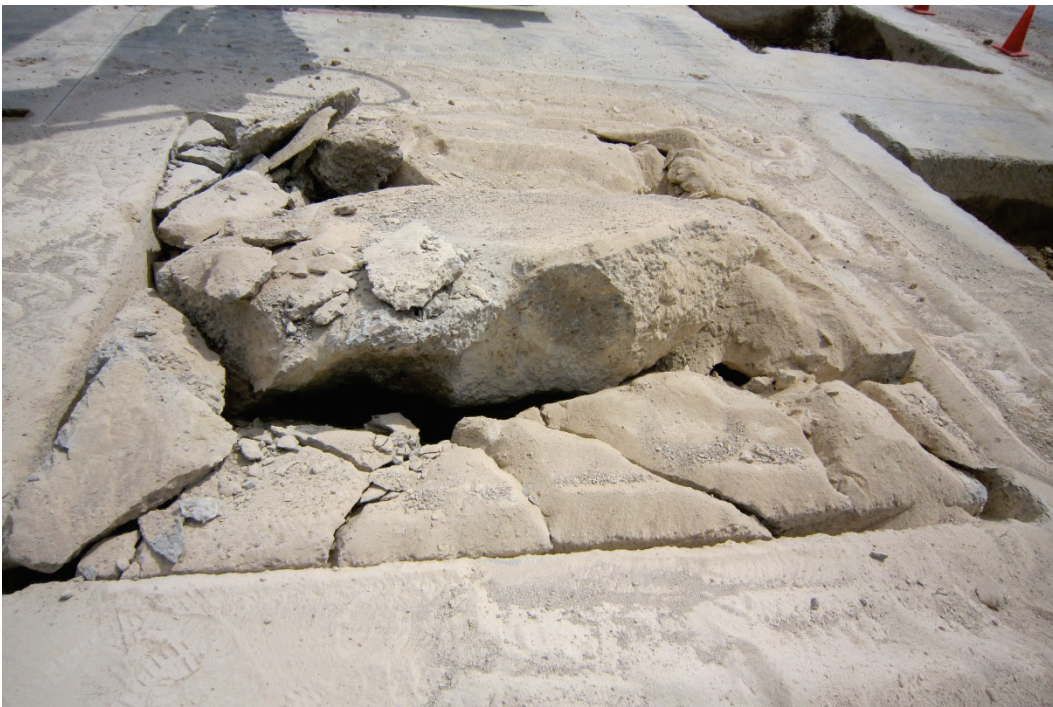
Figure 46. Crater 11, with short overcuts.

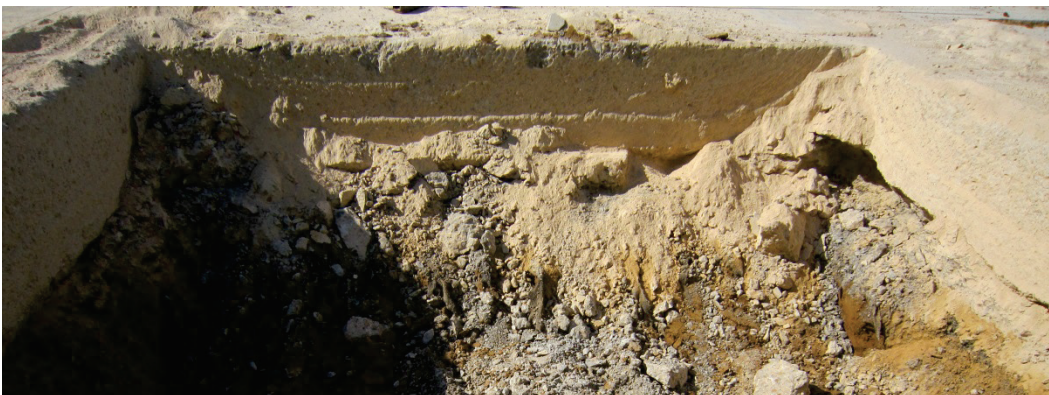
Figure 48. Crater 2, corners broken with bucket.

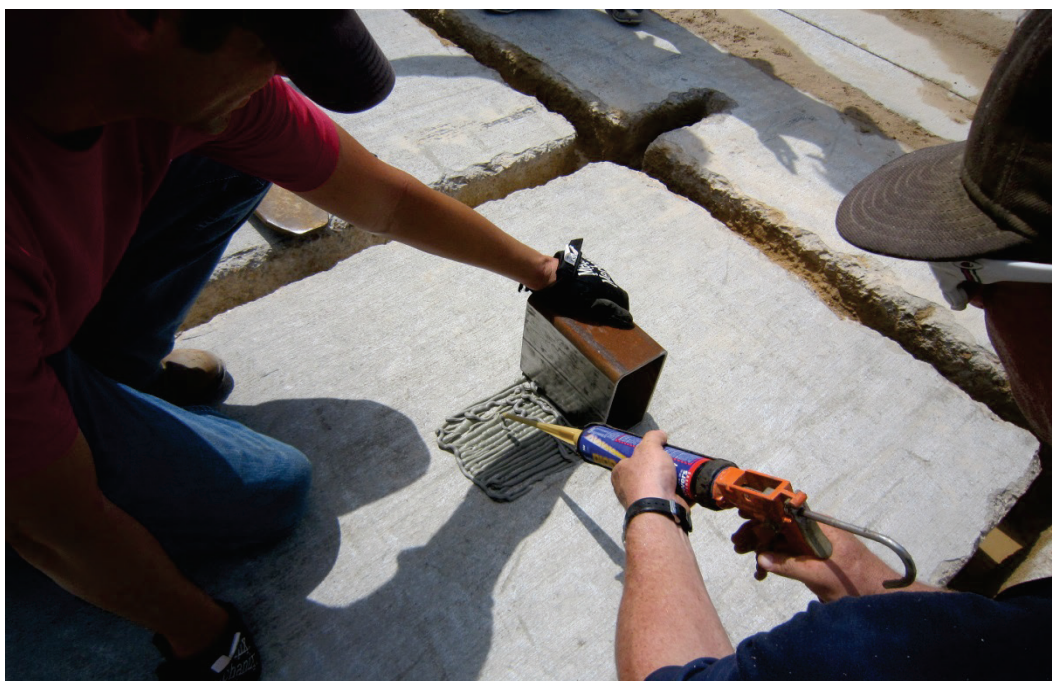
Figure 50. Application of epoxy below steel box beam.

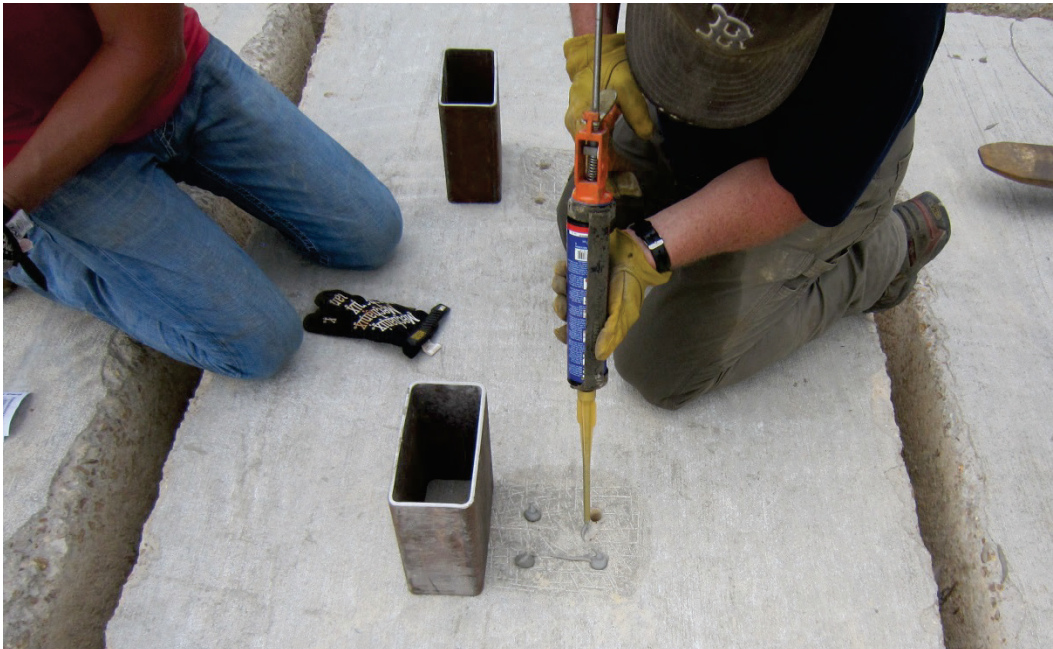
Figure 52. Four drilled holes filled with epoxy.

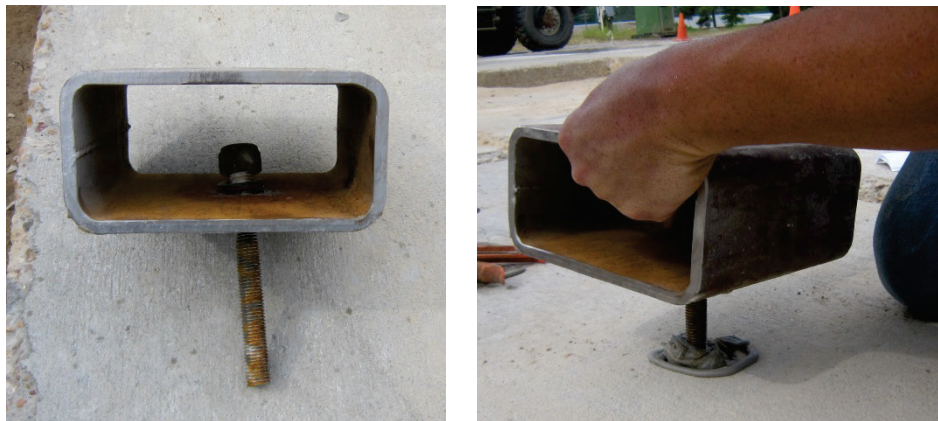
Figure 53. All thread rod with nut, inserted through opening on the bottom of the box beam and placed into drilled hole in PCC.

The fourth anchoring test consisted of using an all thread rod (0.75-in.-diam, 9-in. length) placed in a drilled hole with epoxy for each box beam. A 1-in.-diam opening was drilled on the bottom of both box beams for the all thread rod. A nut (0.75-in.-diam, 1-in. width across the flats, 0.5-in. height) and washer were fitted to the top of each all thread rod and tightened to ensure that the rod remained attached to the box beams (Figure 53). A Bosch hammer drill was used to drill two 1-in.-diam holes 6.5 in. deep within the PCC slab and 3 ft apart. The total drill time for each hole was approximately 2.5 min. One and a half tubes of epoxy (total ~15 oz) was used to fill the two holes to the top of the existing PCC. The box beam was

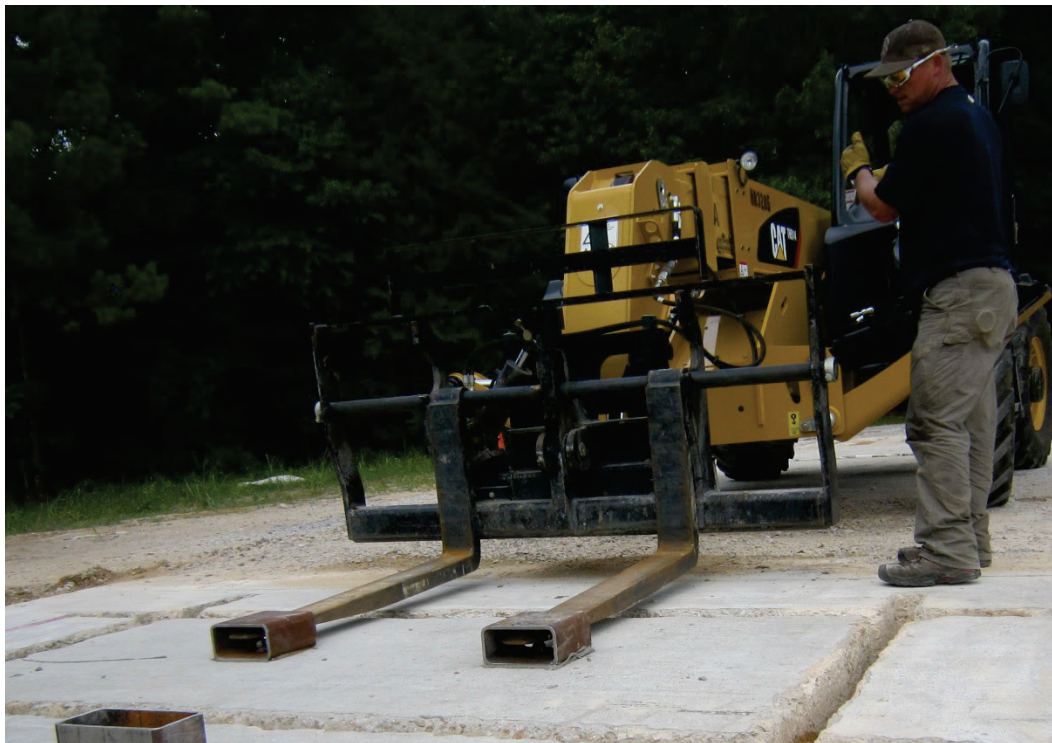
Figure 54. Placing the telehandler forks into the box beams attached with all thread rods with bolts and nuts.

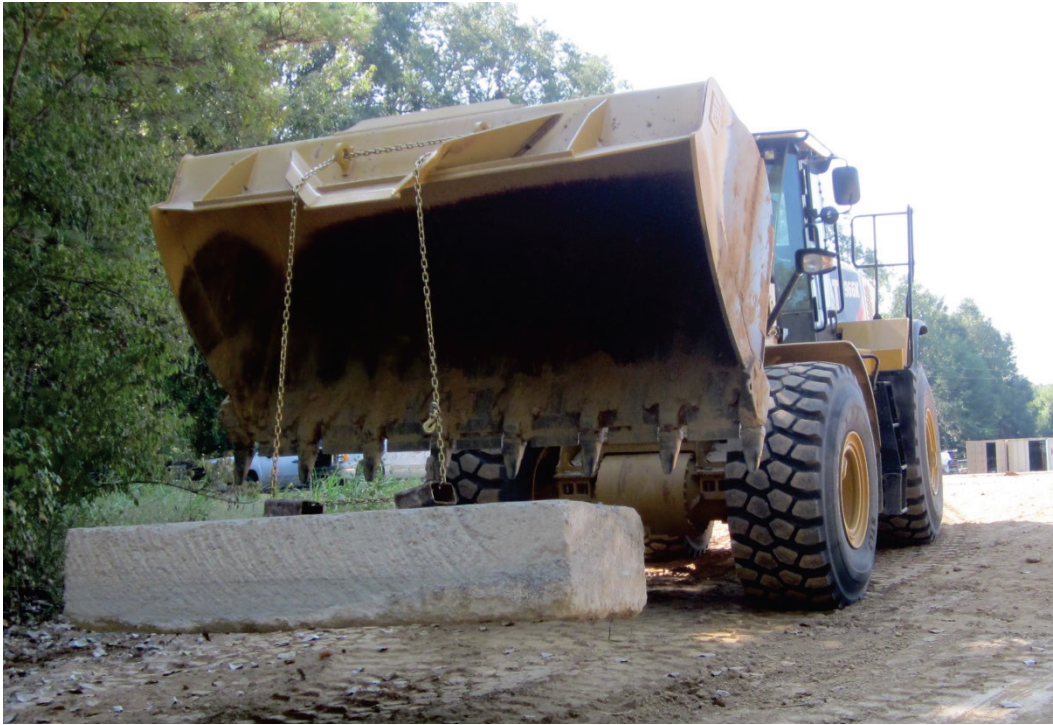
Figure 56. Successful lifting of PCC using eye holes on the front-end loader.

The fifth anchoring test was completed to determine whether the Caterpillar 966K front-end loader with a 4-yd³ bucket could be used to lift the slab. Since the PCC crater repair section of Crater 7 had already been lifted out of the parent slab, this test was conducted simply by lifting the PCC section off the ground. A 14-ft-long tow chain was used to thread through the box beam already attached from the fourth anchoring test. The chain was attached to the front-end loader bucket using the eye holes on the bucket of the front-end loader, as shown in Figure 56. The chain was also tested wrapped around the teeth of the front-end loader, as shown in Figure 57. Both of these attachment techniques were successful in lifting the 4.25-ft by 8.5-ft section of PCC.

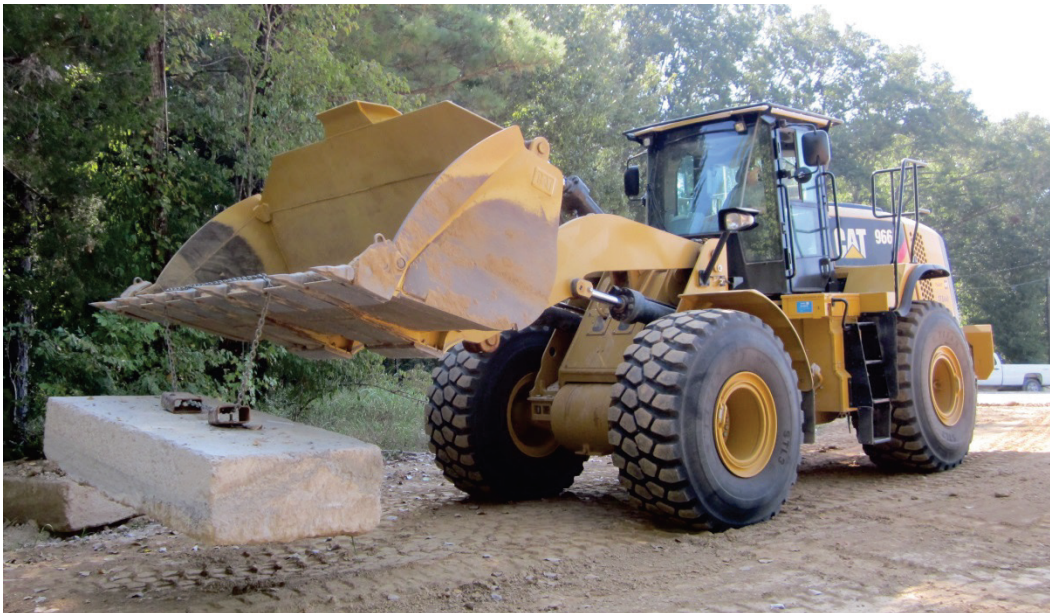
Figure 57. Successful lifting of PCC using the teeth on the front-end loader.
